**Flood Control Project Maintenance  
Levee Inspections**  
**LMA District Cover Sheet**  
**Spring 2017 Levee Inspection Results**

**Sacramento Maintenance Yard Maintenance Area 0009**

Waterway			Bank	Unit Miles
Unit No. 01 Sacramento River			Left	19.35
	Spring (March - May)	Summer (June - August)	(September - November) Fall	Winter (December - February)
Unit Maintenance Rating (Fall Only)				
Date of Inspection	4/25/2017 - 4/26/2017			
DWR Inspector	Zach Jojola			
Accompanied By	Dave Williams Sacramento Maintenance Yard

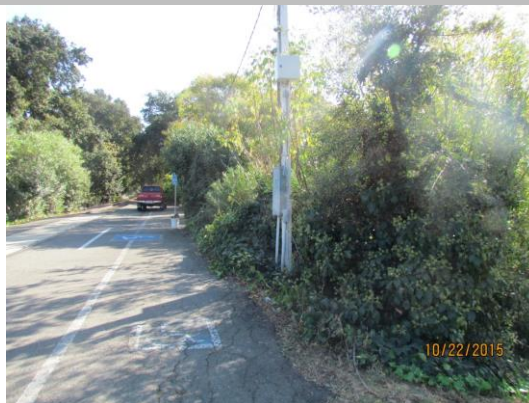
Photo 1 of 1 : SP\_2017\_MA0009\_201\_186\_20170320\_00156.jpg

LM Start	9.58	Rating **	U	Issue No.	186
LM End	9.59	Issue Type +	En	Location *	WS
Category	Earthen Levee			GPS Latitude/Longitude	
				Start	End
Item	Vegetation			38.458242 °	38.458018 °
				-121.501340 °	-121.501317 °
DWR ID	DWR_MA0009_01_s_2012_186				
Comment Code					
V6 : Landscaping					
Inspector Comment					
Trees and shrubs block visibility of levee slopes.

View of the trees and shrubs on the waterward side of the levee looking downstream. This is at the Freeport Marina. Fall 2015.

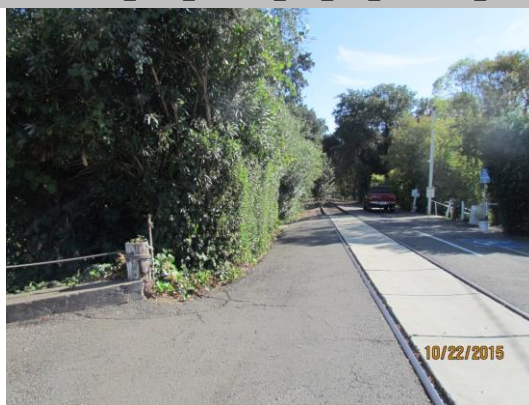
Photo 1 of 1 : SP\_2017\_MA0009\_201\_185\_20170320\_00155.jpg

LM Start	9.58	Rating **	U	Issue No.	185
LM End	9.60	Issue Type +	En	Location *	LS
Category	Earthen Levee			GPS Latitude/Longitude	
				Start	End
Item	Vegetation			38.458242 °	38.457873 °
				-121.501340 °	-121.501290 °
DWR ID	DWR_MA0009_01_s_2012_185				
Comment Code					
V6 : Landscaping					
Inspector Comment

View of the trees and shrubs on the landward side of the levee looking downstream. Fall 2015.

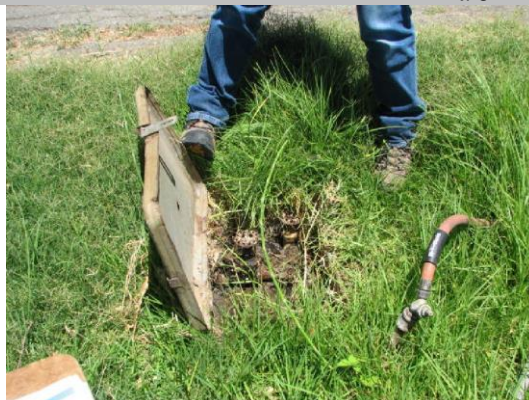
Photo 1 of 2 : UCIP\_SP\_2017\_5104\_6813.jpg

LM Start	9.58	Rating **	M	Issue No.	1799
LM End	9.58	Issue Type +	En	Location *	LS
Category	Supplemental			GPS Latitude/Longitude	
				Start	End
Item	DWR UCIP Field Study			38.458203 °	38.458203 °
				-121.501374 °	-121.501374 °
DWR ID					
Comment Code					
Inspector Comment					
FS_ID:5104 DS_ID:17397 EP_NO: 5150 Repair Type: Non-Urgent Crossing Status: Indicator Found UCIP Comments: There is no permit in this area for a waterline that could be identified. due to the amount of utilities in this area it is unclear if any are authorized. FIELD_STRUCT_DESC: 1 of 2: 1-1/2-inch pipe through levee, 1.0 foot below crown to boating facilities (Permit No's. 1573, 5150, and 5407). Appears to be 1.5-inch PVC waterline at this location. Aluminum box and cover on WS shoulder with valve and distribution header for sprinklers. FS Date: 6/21/2012 11:17:48 AM

Aluminum box and cover on ws shoulder with 1.5-inch waterline and valve.

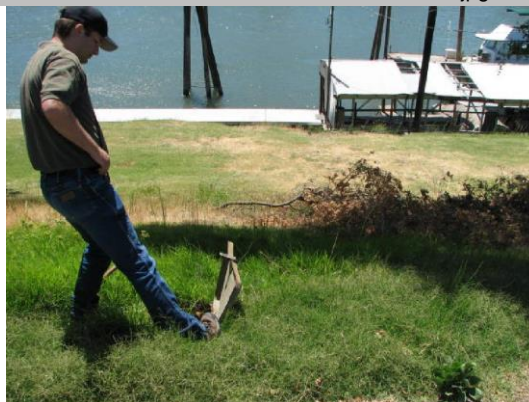
Photo 2 of 2 : UCIP\_SP\_2017\_5104\_6812.jpg

Access box on WS shoulder looking down ws slope.

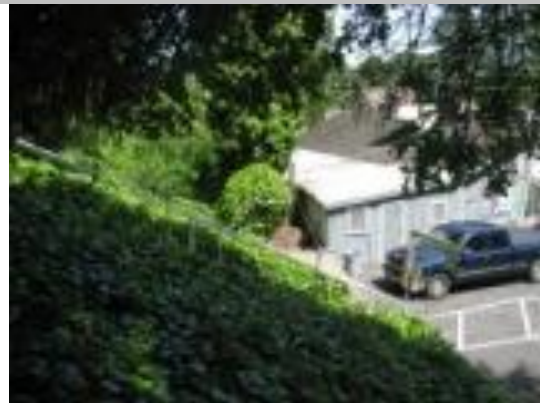
Photo 1 of 2 : SP\_2017\_MA0009\_201\_184\_20170320\_00153.jpg

LM Start	9.59	Rating **	M	Issue No.	184
LM End	9.59	Issue Type +	En	Location *	LS
Category	Earthen Levee			GPS Latitude/Longitude	
				Start	End
Item	Encroachments			38.458078 °	38.458078 °
				-121.501367 °	-121.501367 °
DWR ID	DWR_MA0009_01_s_2012_184				
Comment Code					
BU : Building					
Inspector Comment					
Freeport bait shop.

The Freeport Bait shop is at the toe of the levee. Photo taken spring 2012.

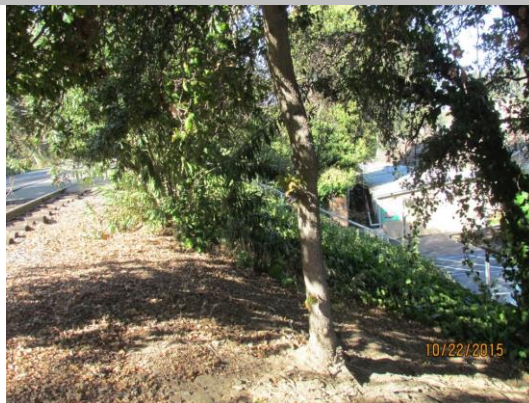
Photo 2 of 2 : SP\_2017\_MA0009\_201\_184\_20170320\_00154.jpg

LM Start	9.59	Rating **	M	Issue No.	184 (cont)	
LM End	9.59	Issue Type +	En	Location *	LS	
Category	Earthen Levee			GPS Latitude/Longitude		
				Start		End
Item	Encroachments			38.458078 °		38.458078 °
				-121.501367 °		-121.501367 °
DWR ID	DWR_MA0009_01_s_2012_184					
Comment Code						
BU : Building						
Inspector Comment						
Freeport bait shop.

View of the Freeport Bat shop at the toe of the levee on the landward side looking upstream. Fall 2015.

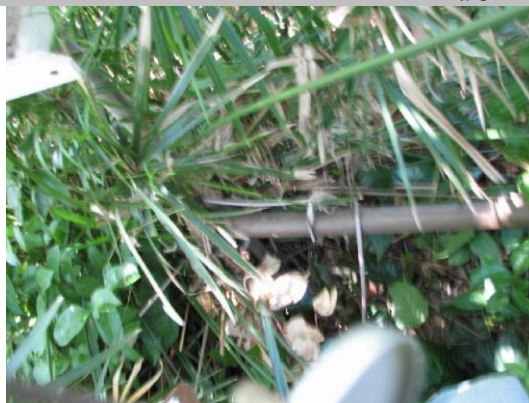
Photo 1 of 3 : UCIP\_SP\_2017\_5908\_8979.jpg

LM Start	9.59	Rating **	M	Issue No.	1801
LM End	9.59	Issue Type +	En	Location *	LS
Category	Supplemental			GPS Latitude/Longitude	
				Start	End
Item	DWR UCIP Field Study			38.458050 °	38.458050 °
				-121.501330 °	-121.501330 °
DWR ID					
Comment Code					
Inspector Comment					
FS_ID:5908 DS_ID:18949 EP_NO: N/A Repair Type: Non-Urgent Crossing Status: Found UCIP Comments: No permit identified for this crossing. FIELD_STRUCT_DESC: 1.5-inch galvanized steel pipe through the levee 1.5-feet below the crown. FS Date: 6/21/2012 3:17:41 PM

Close up of pipe on WS slope.

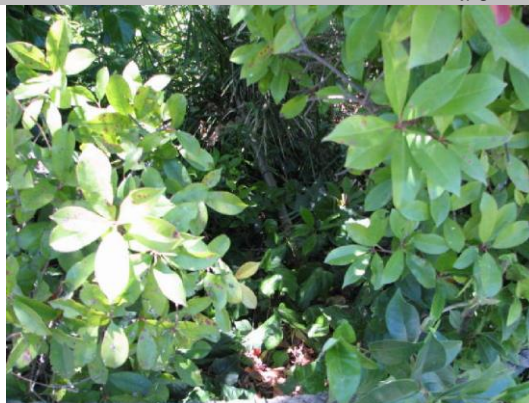
Photo 2 of 3 : UCIP\_SP\_2017\_5908\_8978.jpg

LM Start	9.59	Rating **	M	Issue No.	1801 (cont)	
LM End	9.59	Issue Type +	En	Location *	LS	
Category	Supplemental			GPS Latitude/Longitude		
				Start	End	
Item	DWR UCIP Field Study			38.458050 °	38.458050 °	
				-121.501330 °	-121.501330 °	
DWR ID						
Comment Code						
Inspector Comment						
FS_ID:5908 DS_ID:18949 EP_NO: N/A Repair Type: Non-Urgent Crossing Status: Found UCIP Comments: No permit identified for this crossing. FIELD_STRUCT_DESC: 1.5-inch galvanized steel pipe through the levee 1.5-feet below the crown. FS Date: 6/21/2012 3:17:41 PM

View of pipe on WS slope.

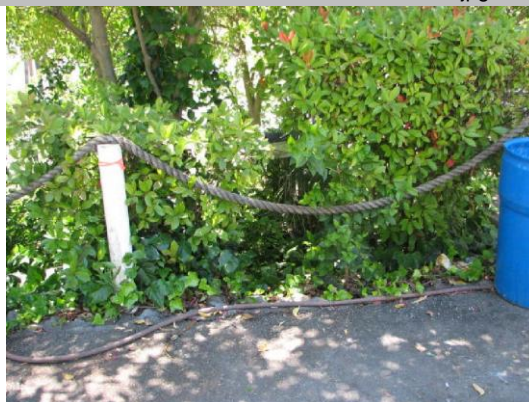
Photo 3 of 3 : UCIP\_SP\_2017\_5908\_8977.jpg

View of pipe location from levee crown looking towards WS slope.

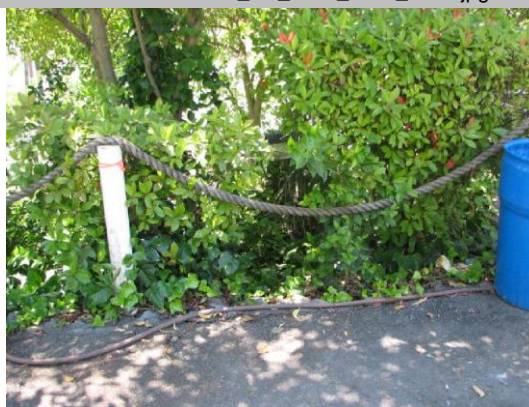
Photo 3 of 3 : UCIP\_SP\_2017\_5107\_6814.jpg

LM Start	9.59	Rating **	M	Issue No.	1803 (cont)	
LM End	9.59	Issue Type +	En	Location *	LS	
Category	Supplemental			GPS Latitude/Longitude		
				Start		End
Item	DWR UCIP Field Study			38.458010 °		38.458010 °
				-121.501320 °		-121.501320 °
DWR ID						
Comment Code						
Inspector Comment						
FS_ID:5107 DS_ID:17646 EP_NO: N/A Repair Type: Non-Urgent Crossing Status: Found UCIP Comments: Due to the amount of utilities in this area it is unclear if any are authorized. This area needs to be cleared of vegetation and thoroughly searched for utility crossings. FIELD_STRUCT_DESC: 2 of 6: 2-inch drain pipe through levee, 3 feet below crown. Main valve in box on waterward slope. Found 1.5-inch steel pipe near this location just upstream of stairs on WS of levee 1.5 feet below crown. FS Date: 6/21/2012 12:59:07 PM

Pipe on WS slope just upstream from stairs.

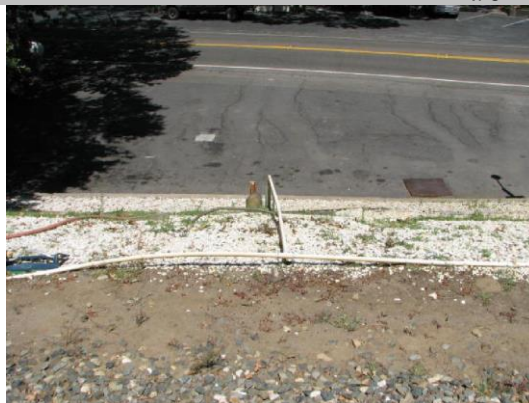
Photo 2 of 3 : UCIP\_SP\_2017\_51247\_20792.jpg

Comment Code					
Inspector Comment					
FS_ID:51247 DS_ID:18950 EP_NO: N/A Repair Type: Urgent Crossing Status: Found UCIP Comments: 12/01/2016 same as last inspection conduit is open through the levee. Unable to locate WS daylight due to dense vegetation. Need to contact owner to determine status of crossing. If crossing is abandoned, owner will need to coordinate with the CVFPB to comply with Title 23. (O. Magana - DWR UCIP)06/21/2012 Open conduit through the levee. No permit identified for this crossing. (W. Wylie - DWR UCIP) FIELD_STRUCT_DESC: 1 of 2: 5-inch galvanized steel water pipe through the levee, 3 feet below the crown. Pipe open on both ends. FS Date: 12/2/2016

View of PVC pipe running through 2nd pipe.

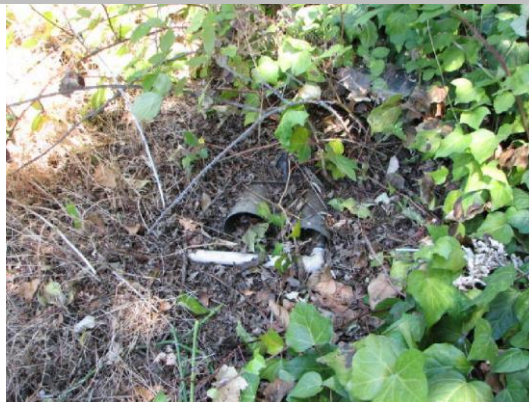
Photo 3 of 3 : UCIP\_SP\_2017\_51247\_20791.jpg

Both pipes on WS shoulder.

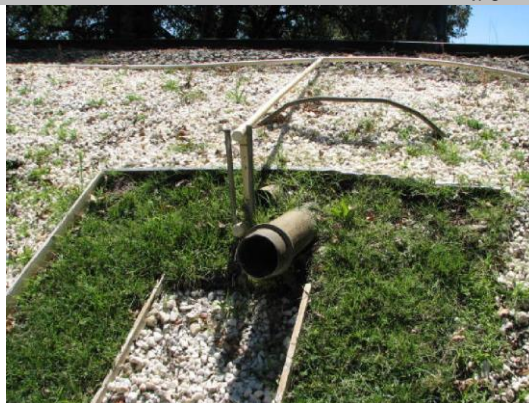
Photo 1 of 3 : UCIP\_SP\_2017\_51248\_20796.jpg

FS\_ID:51248  
DS\_ID:18951  
EP\_NO: N/A  
Repair Type: Urgent  
Crossing Status: Found  
UCIP Comments: 12/02/2016 same as last inspection conduit is open through the levee. Unable to locate WS daylight due to dense vegetation. Need to contact owner to determine status of crossing. If crossing is abandoned, owner will need to coordinate with the CVFPB to comply with Title 23. (O. Magana - DWR UCIP)06/21/2012 Pipe open on both ends. No permit identified for this crossing. (W. Wylie - DWR UCIP)  
FIELD\_STRUCT\_DESC: 2 of 2: 5-inch galvanized steel water pipe through the levee, 3 feet below the crown. Pipe open on both ends.  
FS Date: 12/2/2016

Both pipes through grass sign on LS slope.

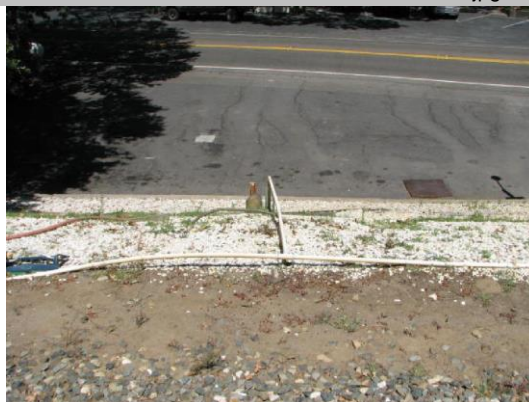
Photo 2 of 3 : UCIP\_SP\_2017\_51248\_20795.jpg

PVC waterline running through pipe on LS slope.

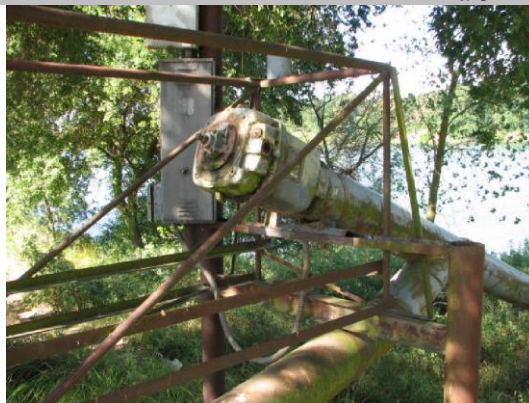
Photo 2 of 3 : UCIP\_SP\_2017\_5117\_6829.jpg

LM Start	9.80	Rating **	M	Issue No.	1811 (cont)
LM End	9.80	Issue Type +	En	Location *	LS
Category	Supplemental			GPS Latitude/Longitude	
				Start	End
Item	DWR UCIP Field Study			38.455040 °	38.455040 °
				-121.500450 °	-121.500450 °
DWR ID					
Comment Code					
Inspector Comment					
FS_ID:5117					
DS_ID:17439					
EP_NO: N/A					
Repair Type: Non-Urgent					
Crossing Status: Found					
UCIP Comments: Walkway unsafe and could pose attractive nuisance to minors. Walkway should be repaired or removed.					
FIELD_STRUCT_DESC: 14-inch pipe through levee, 7.2 feet below crown. Pump on pile structure in stream. Overhead power line crosses levee to pole and meter next to pump. Ramp on landward slope. Permit No. 1449, 1949. Included in O+M manual (1955).					
FS Date: 6/22/2012 1:36:29 PM

Pump next to meter on pole, WS.

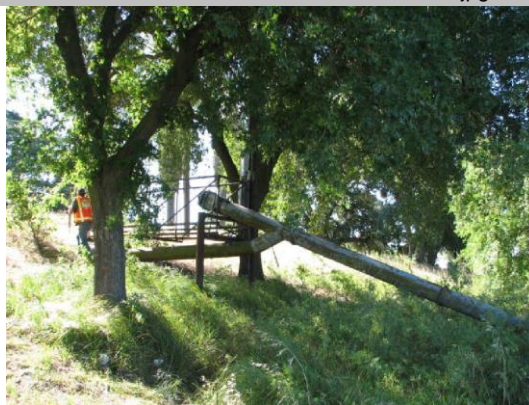
Photo 3 of 3 : UCIP\_SP\_2017\_5117\_6828.jpg

Pump and pipe on WS of levee.

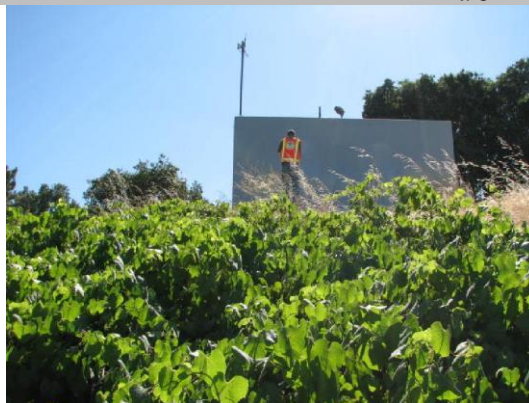
Photo 1 of 2 : UCIP\_SP\_2017\_5920\_9002.jpg

LM Start	9.85	Rating **	M	Issue No.	1812
LM End	9.85	Issue Type +	En	Location *	LS
Category	Supplemental			GPS Latitude/Longitude	
				Start	End
Item	DWR UCIP Field Study			38.454360 °	38.454360 °
				-121.500300 °	-121.500300 °
DWR ID					
Comment Code					
Inspector Comment					
FS_ID:5920 DS_ID:18953 EP_NO: N/A Repair Type: Non-Urgent Crossing Status: Found UCIP Comments: No permit identified for this crossing. FIELD_STRUCT_DESC: 2-inch PVC pipe found on WS toe. Unclear if pipe penetrates levee. FS Date: 6/22/2012 3:33:20 PM

Pipe alignment from waters edge to upstream corner of building on WS shoulder of levee.

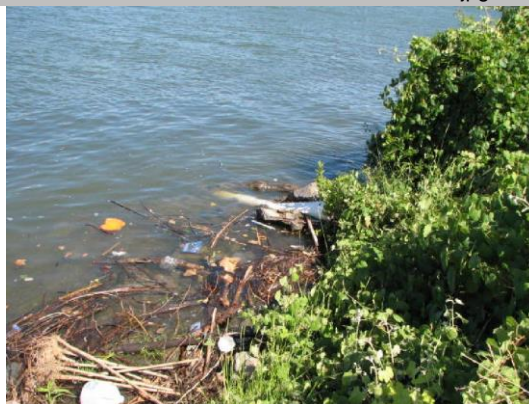
Photo 2 of 2 : UCIP\_SP\_2017\_5920\_9001.jpg

Pipe on WS toe at river.

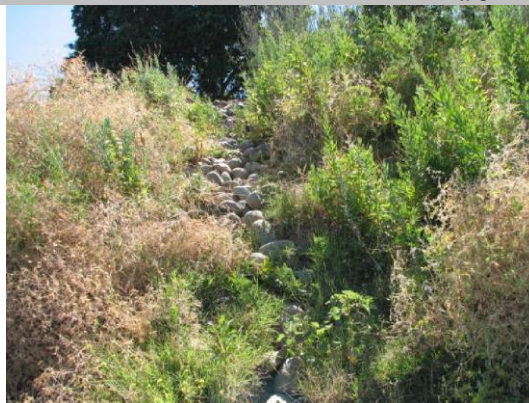
Photo 1 of 2 : UCIP\_SP\_2017\_5921\_9004.jpg

FS\_ID:5921  
DS\_ID:18954  
EP\_NO: N/A  
Repair Type: Non-Urgent  
Crossing Status: Indicator Found  
UCIP Comments: No permit identified for this crossing.  
FIELD\_STRUCT\_DESC: Trenchwork through levee. Evidence of unidentified utility crossing.  
FS Date: 6/22/2012 3:38:59 PM

Trench work down WS slope.

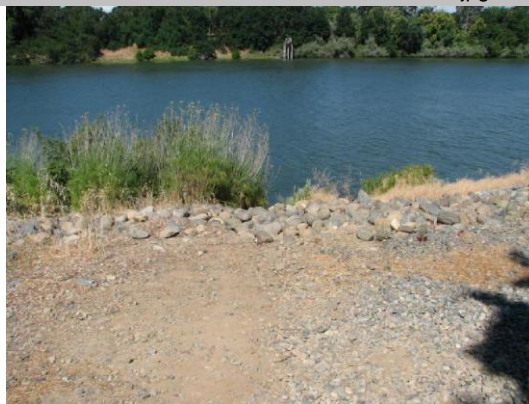
Photo 2 of 2 : UCIP\_SP\_2017\_5921\_9003.jpg

Trench work from under RR tracks across crown down WS slope.

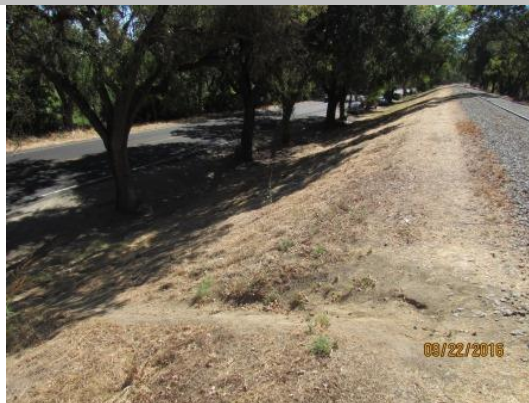
Photo 1 of 2 : SP\_2017\_MA0009\_201\_360\_20170320\_00273.jpg

An updated view of a footpath on LS slope of the levee. Fall 2016.

LM Start	9.92	Rating **	M	Issue No.	360
LM End	9.92	Issue Type +	Ma	Location *	LS
Category	Earthen Levee			GPS Latitude/Longitude	
				Start	End
Item	Slope Stability			38.453408 °	38.453408 °
				-121.500167 °	-121.500167 °
DWR ID	DWR_MA0009_01_f_2015_360				
Comment Code					
S2 : Repair the levee slope damaged by foot traffic and prevent access where possible.					
Inspector Comment

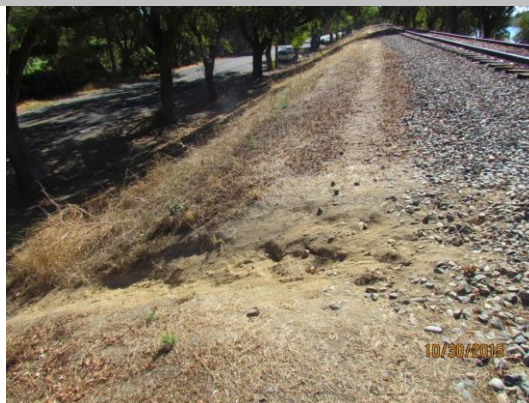
Photo 2 of 2 : SP\_2017\_MA0009\_201\_360\_20170320\_00274.jpg

View of the slope stability on the landward side of the levee looking downstream. Fall 2015.

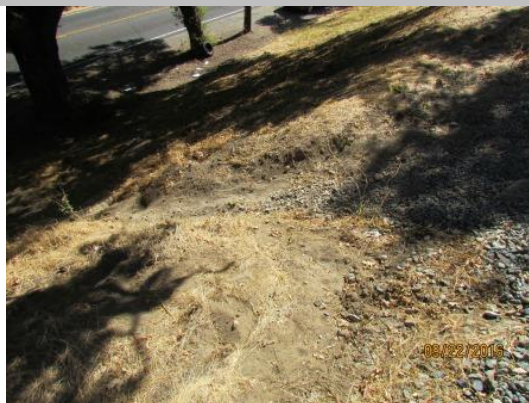
Photo 1 of 2 : SP\_2017\_MA0009\_201\_361\_20170320\_00275.jpg

An update view of a footpath on LS slope of the levee. Fall 2016.

LM Start	9.94	Rating **	M	Issue No.	361
LM End	9.94	Issue Type +	Ma	Location *	LS
Category	Earthen Levee			GPS Latitude/Longitude	
				Start	End
Item	Slope Stability			38.453095 °	38.453095 °
				-121.500147 °	-121.500147 °
DWR ID	DWR_MA0009_01_f_2015_361				
Comment Code					
S2 : Repair the levee slope damaged by foot traffic and prevent access where possible.					
Inspector Comment

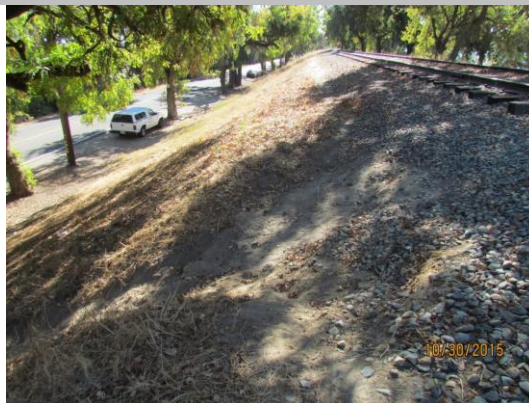
Photo 2 of 2 : SP\_2017\_MA0009\_201\_361\_20170320\_00276.jpg

View of the slope stability on the landward side of the levee looking downstream. Fall 2015.

LM Start	9.94	Rating **	M	Issue No.	361 (cont)	
LM End	9.94	Issue Type +	Ma	Location *	LS	
Category	Earthen Levee			GPS Latitude/Longitude		
				Start		End
Item	Slope Stability			38.453095 °		38.453095 °
				-121.500147 °		-121.500147 °
DWR ID	DWR_MA0009_01_f_2015_361					
Comment Code						
S2 : Repair the levee slope damaged by foot traffic and prevent access where possible.						
Inspector Comment

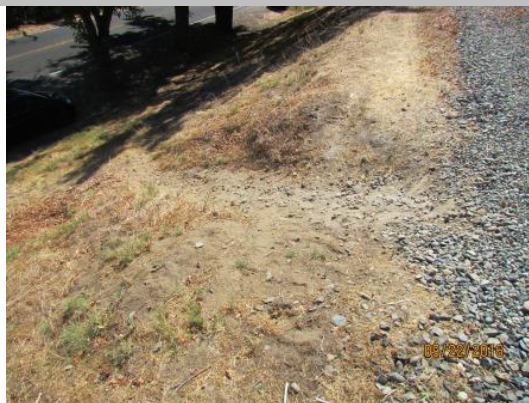
Photo 1 of 2 : SP\_2017\_MA0009\_201\_362\_20170320\_00277.jpg

LM Start	9.96	Rating **	M	Issue No.	362
LM End	9.96	Issue Type +	Ma	Location *	LS
Category	Earthen Levee			GPS Latitude/Longitude	
				Start	End
Item	Slope Stability			38.452728 °	38.452728 °
				-121.500100 °	-121.500100 °
DWR ID	DWR_MA0009_01_f_2015_362				
Comment Code					
S2 : Repair the levee slope damaged by foot traffic and prevent access where possible.					
Inspector Comment

Updated view of a footpath on LS slope of the levee. Fall 2016.

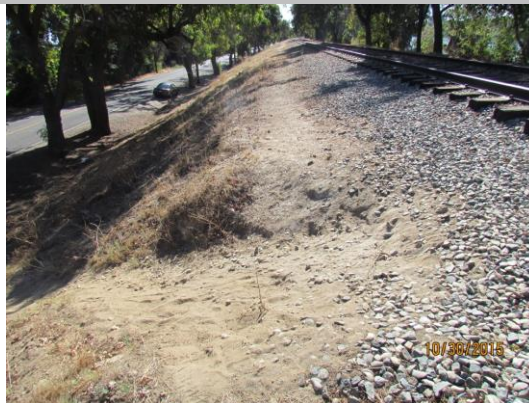
Photo 2 of 2 : SP\_2017\_MA0009\_201\_362\_20170320\_00278.jpg

View of the slope stability on the landward side of the levee looking downstream. Fall 2015.

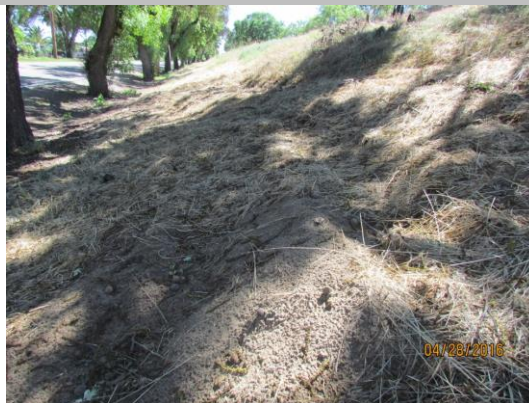
Photo 1 of 2 : SP\_2017\_MA0009\_201\_363\_20170320\_00279.jpg

LM Start	10.02	Rating **	M	Issue No.	363
LM End	10.02	Issue Type +	Ma	Location *	LS
Category	Earthen Levee			GPS Latitude/Longitude	
				Start	End
Item	Animal Control			38.451907 °	38.451907 °
				-121.500047 °	-121.500047 °
DWR ID	DWR_MA0009_01_f_2015_363				
Comment Code					
A3 : No rodents visible, but rodent burrows visible; need to backfill and compact or grout burrows.					
Inspector Comment

Perspective view of the rodent hole on the landward side of the levee looking downstream. Spring 2016.

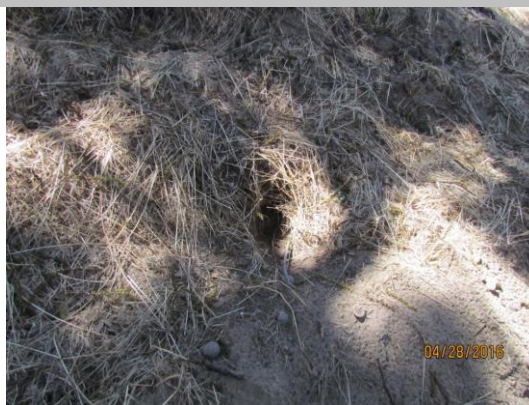
Photo 2 of 2 : SP\_2017\_MA0009\_201\_363\_20170320\_00280.jpg

Rodent hole is about midway down the slope of the levee. Spring 2016.

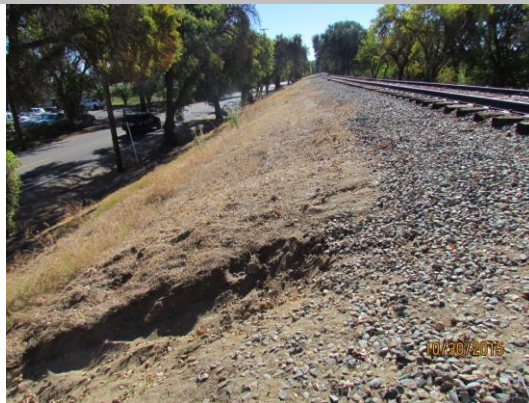
Photo 1 of 1 : SP\_2017\_MA0009\_201\_364\_20170320\_00281.jpg

LM Start	10.03	Rating **	M	Issue No.	364
LM End	10.03	Issue Type +	Ma	Location *	LS
Category	Earthen Levee			GPS Latitude/Longitude	
				Start	End
Item	Slope Stability			38.451717 °	38.451717 °
				-121.500002 °	-121.500002 °
DWR ID	DWR_MA0009_01_f_2015_364				
Comment Code					
S2 : Repair the levee slope damaged by foot traffic and prevent access where possible.					
Inspector Comment

View of the slope stability on the landward side of the levee looking downstream. Fall 2015.

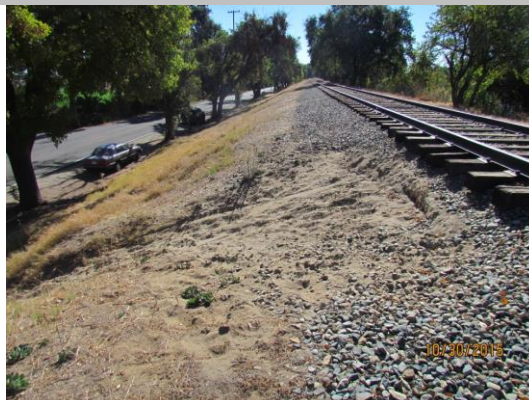
Photo 1 of 1 : SP\_2017\_MA0009\_201\_365\_20170320\_00282.jpg

LM Start	10.05	Rating **	M	Issue No.	365
LM End	10.05	Issue Type +	Ma	Location *	LS
Category	Earthen Levee			GPS Latitude/Longitude	
				Start	End
Item	Slope Stability			38.451468 °	38.451468 °
				-121.500030 °	-121.500030 °
DWR ID	DWR_MA0009_01_f_2015_365				
Comment Code					
S2 : Repair the levee slope damaged by foot traffic and prevent access where possible.					
Inspector Comment

View of the slope stability on the landward side of the levee looking downstream. Fall 2015.

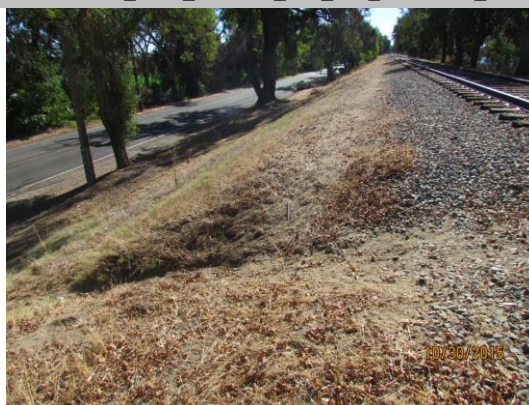
Photo 1 of 1 : SP\_2017\_MA0009\_201\_366\_20170320\_00283.jpg

LM Start	10.09	Rating **	M	Issue No.	366
LM End	10.09	Issue Type +	Ma	Location *	LS
Category	Earthen Levee			GPS Latitude/Longitude	
				Start	End
Item	Slope Stability			38.450913 °	38.450913 °
				-121.500045 °	-121.500045 °
DWR ID	DWR_MA0009_01_f_2015_366				
Comment Code					
S2 : Repair the levee slope damaged by foot traffic and prevent access where possible.					
Inspector Comment

View of the slope stability on the landward side of the levee looking downstream. Fall 2015.

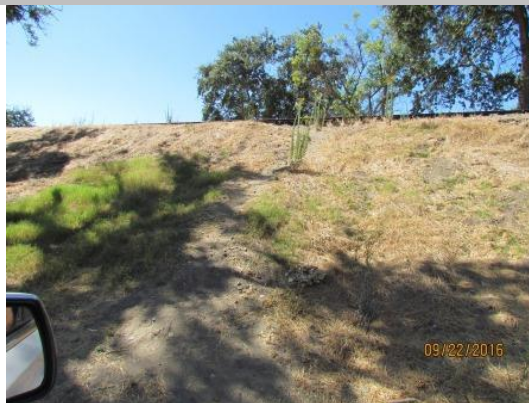
Photo 1 of 2 : SP\_2017\_MA0009\_201\_381\_20170320\_00295.jpg

LM Start	10.12	Rating **	M	Issue No.	381
LM End	10.12	Issue Type +	Ma	Location *	LS
Category	Earthen Levee			GPS Latitude/Longitude	
				Start	End
Item	Slope Stability			38.450427 °	38.450427 °
				-121.500032 °	-121.500032 °
DWR ID	DWR_MA0009_01_s_2016_381				
Comment Code					
S3 : Repair the levee slope damaged by vehicle traffic and prevent access where possible.					
Inspector Comment

View from Hwy 160 on slope stability site on LS slope of the levee. Fall 2016.

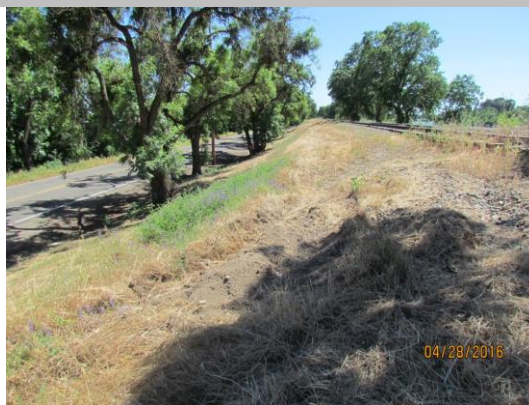
Photo 2 of 2 : SP\_2017\_MA0009\_201\_381\_20170320\_00296.jpg

View of the slope stability on the landward side of the levee looking downstream. Spring 2016.

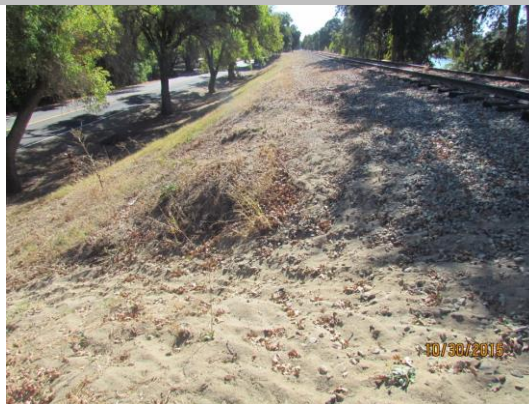
Photo 1 of 1 : SP\_2017\_MA0009\_201\_368\_20170320\_00286.jpg

LM Start	10.15	Rating **	M	Issue No.	368
LM End	10.15	Issue Type +	Ma	Location *	LS
Category	Earthen Levee			GPS Latitude/Longitude	
				Start	End
Item	Slope Stability			38.449967 °	38.449967 °
				-121.500053 °	-121.500053 °
DWR ID	DWR_MA0009_01_f_2015_368				
Comment Code					
S2 : Repair the levee slope damaged by foot traffic and prevent access where possible.					
Inspector Comment

View of the slope stability on the landward side of the levee looking downstream. Fall 2015.

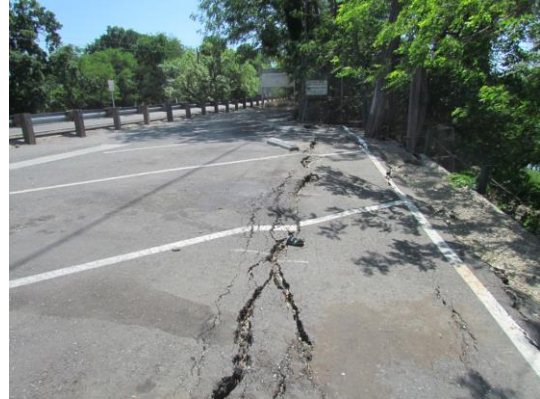
Photo 1 of 1 : SP\_2017\_MA0009\_201\_309\_20170320\_00229.jpg

LM Start	10.54	Rating **	M	Issue No.	309
LM End	10.54	Issue Type +	Ob	Location *	WS
Category	Earthen Levee			GPS Latitude/Longitude	
				Start	End
Item	Cracking			38.444353 °	38.444353 °
				-121.500472 °	-121.500472 °
DWR ID	DWR_MA0009_01_s_2015_309				
Comment Code					
CR1 : Monitor and have inspected by geotechnical engineer.					
Inspector Comment

View of the crack on the water ward side of the levee looking downstream. Spring 2015.

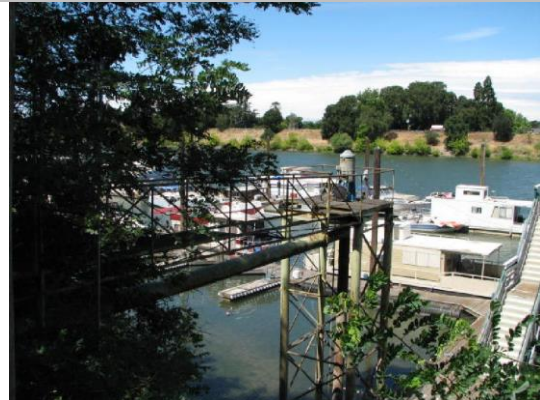
Photo 1 of 3 : UCIP\_SP\_2017\_9443\_16422.jpg

LM Start	10.56	Rating **	M	Issue No.	1814
LM End	10.56	Issue Type +	En	Location *	WS
Category	Supplemental			GPS Latitude/Longitude	
				Start	End
Item	DWR UCIP Field Study			38.444136 °	38.444136 °
				-121.500414 °	-121.500414 °
DWR ID					
Comment Code					
Inspector Comment					
FS_ID:9443 DS_ID:18957 EP_NO: N/A Repair Type: Non-Urgent Crossing Status: Found UCIP Comments: No permit identified for this crossing. FIELD_STRUCT_DESC: 14-inch steel irrigation pipe through the levee 3.5-feet below the crown. Pump on elevated pier with elevated walkway on waterside shoulder. 48-inch concrete distribution box on LS toe. Permit No. 1629, 1952. FS Date: 6/22/2012 3:46:00 PM

Pump on elevated pier on WS.

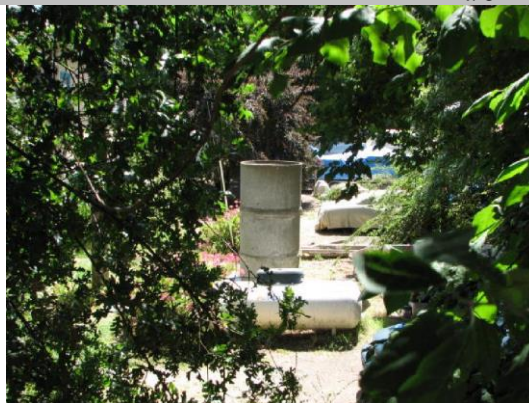
Photo 2 of 3 : UCIP\_SP\_2017\_9443\_16423.jpg

Concrete Standpipe on LS in homeowners yard.

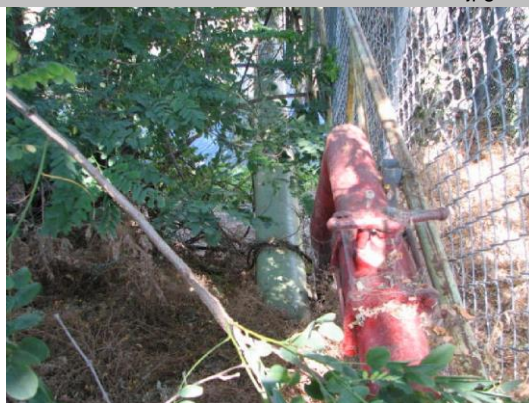
Photo 3 of 3 : UCIP\_SP\_2017\_9443\_16424.jpg

Pipe, Fire Connection, and Fenced in Walway on WS shoulder.

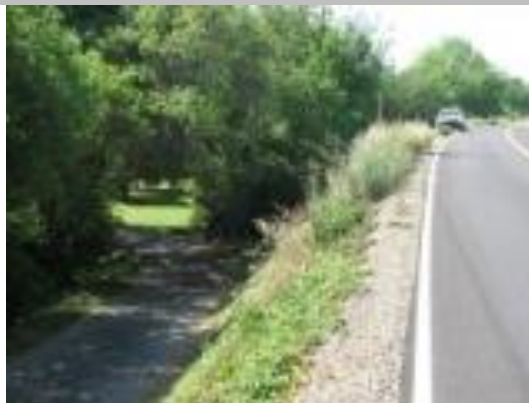
Photo 2 of 2 : SP\_2017\_MA0009\_201\_220\_20170320\_00178.jpg

LM Start	10.77	Rating **	M	Issue No.	220 (cont)	
LM End	10.77	Issue Type +	En	Location *	LS	
Category	Earthen Levee			GPS Latitude/Longitude		
				Start		End
Item	Vegetation			38.441133 °		38.441133 °
				-121.501632 °		-121.501632 °
DWR ID	DWR_MA0009_01_s_2012_220					
Comment Code						
V6 : Landscaping						
Inspector Comment

A view of the drive and landscape. Photo taken spring 2012.

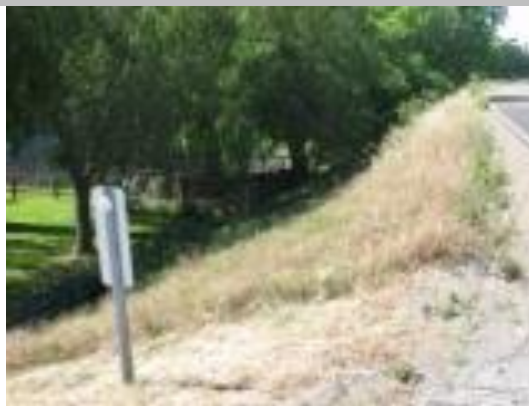
Photo 1 of 1 : SP\_2017\_MA0009\_201\_219\_20170320\_00176.jpg

LM Start	10.82	Rating **	M	Issue No.	219
LM End	10.82	Issue Type +	En	Location *	LS
Category	Earthen Levee			GPS Latitude/Longitude	
				Start	End
Item	Vegetation			38.440577 °	38.440577 °
				-121.502058 °	-121.502058 °
DWR ID	DWR_MA0009_01_s_2012_219				
Comment Code					
V6 : Landscaping					
Inspector Comment

A view of the horse corral and some landscape. Photo taken spring 2012.

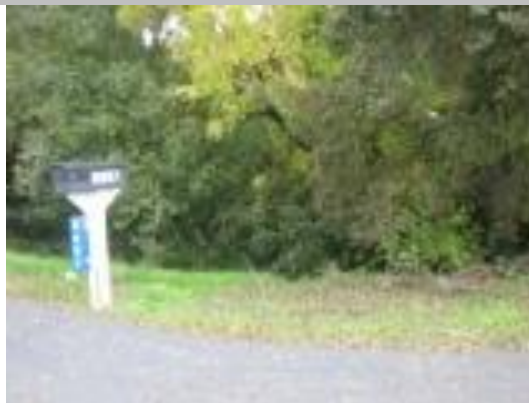
Photo 1 of 1 : SP\_2017\_MA0009\_201\_161\_20170320\_00123.jpg

LM Start	10.95	Rating **	M	Issue No.	161
LM End	10.95	Issue Type +	En	Location *	LS
Category	Earthen Levee			GPS Latitude/Longitude	
				Start	End
Item	Vegetation			38.439031 °	38.439031 °
				-121.503463 °	-121.503463 °
DWR ID	DWR_MA0009_01_f_2012_161				
Comment Code					
V6 : Landscaping					
Inspector Comment

Landscape planted at toe of levee. Fall 2012

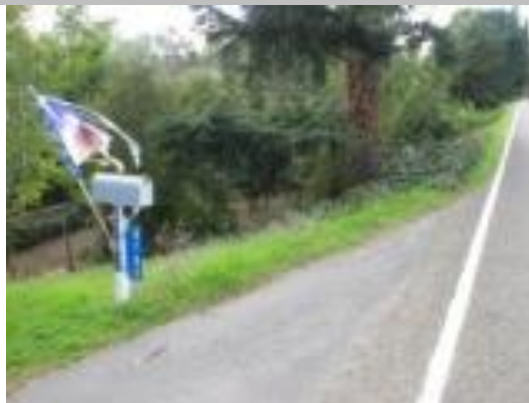
Photo 1 of 1 : SP\_2017\_MA0009\_201\_160\_20170320\_00122.jpg

LM Start	10.96	Rating **	M	Issue No.	160
LM End	10.96	Issue Type +	En	Location *	LS
Category	Earthen Levee			GPS Latitude/Longitude	
				Start	End
Item	Vegetation			38.438883 °	38.438883 °
				-121.503654 °	-121.503654 °
DWR ID	DWR_MA0009_01_f_2012_160				
Comment Code					
V6 : Landscaping					
Inspector Comment

Groundcover and shrubs on the slope and toe of levee. Fall 2012

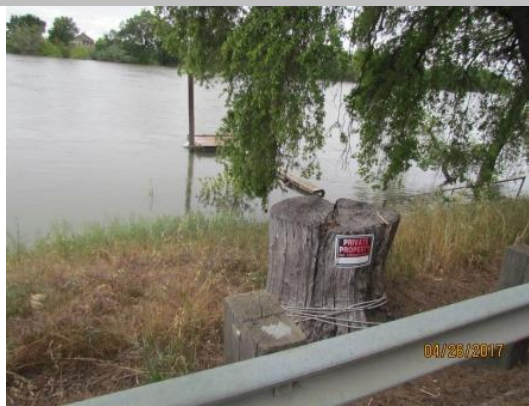
Photo 1 of 1 : SP\_2017\_MA0009\_201\_306\_20170426\_00510.jpg

LM Start	11.02	Rating **	N	Issue No.	306
LM End	11.02	Issue Type +	Ma	Location *	WS
Category	Earthen Levee			GPS Latitude/Longitude	
				Start	End
Item	Trim / Thin Trees			38.438314 °	38.438314 °
				-121.504306 °	-121.504306 °
DWR ID	DWR_MA0009_01_s_2017_306				
Comment Code					
T5 : Tree stumps.					
Inspector Comment

View of stump on waterside levee slope. Spring 2017.

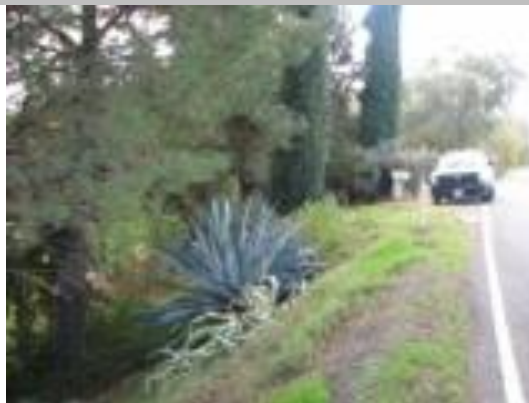
Photo 1 of 1 : SP\_2017\_MA0009\_201\_154\_20170320\_00114.jpg

LM Start	11.03	Rating **	M	Issue No.	154
LM End	11.03	Issue Type +	En	Location *	LS
Category	Earthen Levee			GPS Latitude/Longitude	
				Start	End
Item	Vegetation			38.438178 °	38.438178 °
				-121.504409 °	-121.504409 °
DWR ID	DWR_MA0009_01_f_2012_154				
Comment Code					
V6 : Landscaping					
Inspector Comment

Agave and shrubs planted on levee slope. Fall 2012

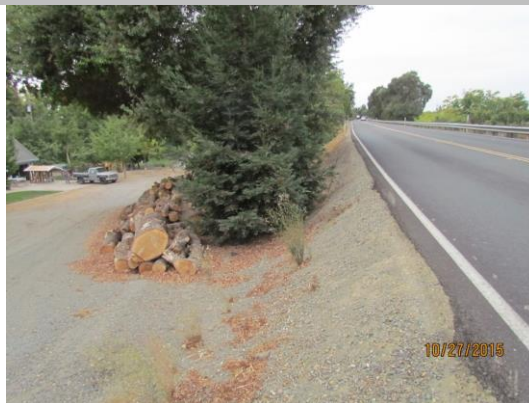
Photo 1 of 1 : SP\_2017\_MA0009\_201\_357\_20170320\_00270.jpg

LM Start	11.04	Rating **	M	Issue No.	357
LM End	11.04	Issue Type +	En	Location *	LS
Category	Earthen Levee			GPS Latitude/Longitude	
				Start	End
Item	Encroachments			38.438065 °	38.438065 °
				-121.504606 °	-121.504606 °
DWR ID	DWR_MA0009_01_f_2015_357				
Comment Code					
FW : Firewood					
Inspector Comment

View of the firewood along the toe of the levee on the landward side looking downstream. Fall 2015.

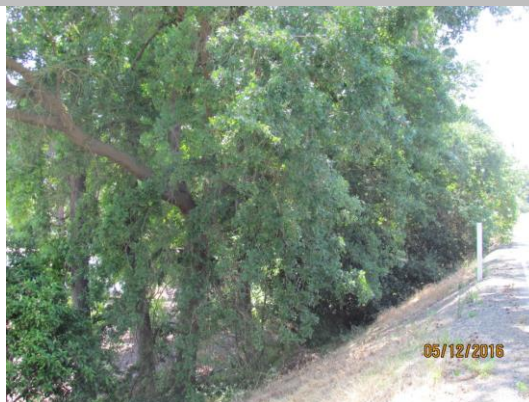
Photo 1 of 1 : SP\_2017\_MA0009\_201\_72\_20170320\_00048.jpg

LM Start	11.19	Rating **	M	Issue No.	72
LM End	11.19	Issue Type +	En	Location *	LS
Category	Earthen Levee			GPS Latitude/Longitude	
				Start	End
Item	Vegetation			38.436735 °	38.436735 °
				-121.506647 °	-121.506647 °
DWR ID	DWR_MA0009_01_f_2012_72				
Comment Code					
V6 : Landscaping					
Inspector Comment

View of the landscape on the landward side of the levee looking downstream. Spring 2016.

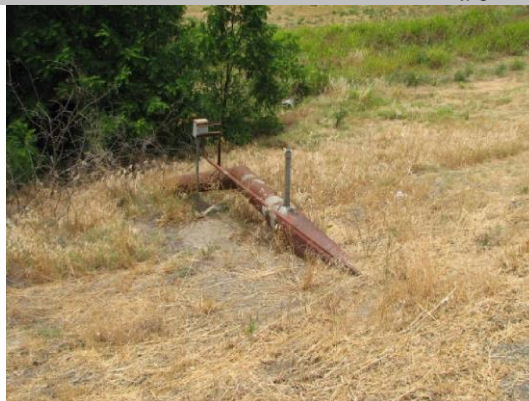
Photo 1 of 3 : UCIP\_SP\_2017\_5129\_6861.jpg

LM Start	11.23	Rating **	M	Issue No.	1815
LM End	11.23	Issue Type +	En	Location *	LS
Category	Supplemental			GPS Latitude/Longitude	
				Start	End
Item	DWR UCIP Field Study			38.436370 °	38.436370 °
				-121.507300 °	-121.507300 °
DWR ID					
Comment Code					
Inspector Comment					
FS_ID:5129					
DS_ID:17457					
EP_NO: N/A					
Repair Type: Non-Urgent					
Crossing Status: Found					
UCIP Comments: Determine if this pipe is grouted in place.					
FIELD_STRUCT_DESC: *ABANDONED* 14-inch pipe through levee, 5.0 feet below-crown. Pump and butterfly valve in pump house on waterward slope. 1.5-inch galvanized steel pipe 5-feet below crown provides electricity. 36-inch Concrete standpipe on LS toe. Permit No. 1215, 1947. included in O+M manual (1955). May have been grouted in place as there are grouting standpipes on both the LS and WS shoulder.					
FS Date: 6/22/2012 2:48:01 PM

14-inch steel pipe on LS slope with 36-inch concrete standpipe in trees at toe.

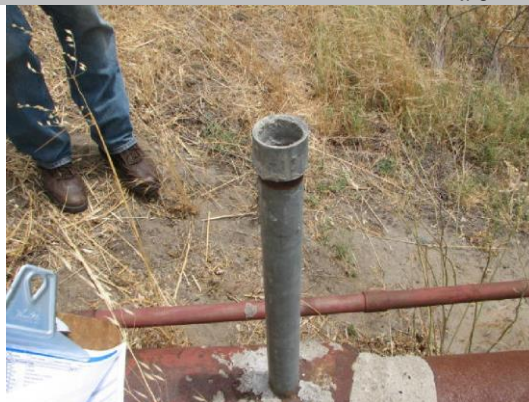
Photo 2 of 3 : UCIP\_SP\_2017\_5129\_6860.jpg

Grouting attachment at LS.

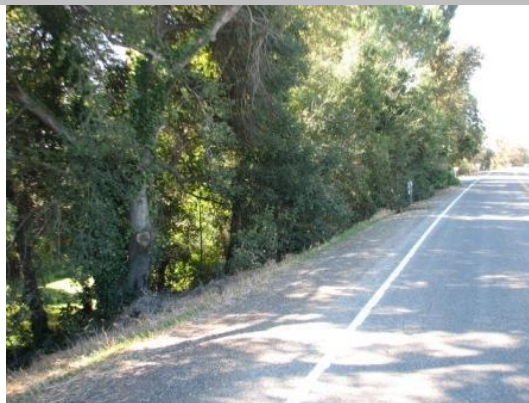
Photo 1 of 2 : SP\_2017\_MA0009\_201\_212\_20170320\_00174.jpg

LM Start	11.33	Rating **	M	Issue No.	212
LM End	11.33	Issue Type +	En	Location *	LS
Category	Earthen Levee			GPS Latitude/Longitude	
				Start	End
Item	Vegetation			38.435647 °	38.435647 °
				-121.508891 °	-121.508891 °
DWR ID	DWR_MA0009_01_s_2012_212				
Comment Code					
V6 : Landscaping					
Inspector Comment

Vegetation on the levee slope partially block visibility. Fall 2013

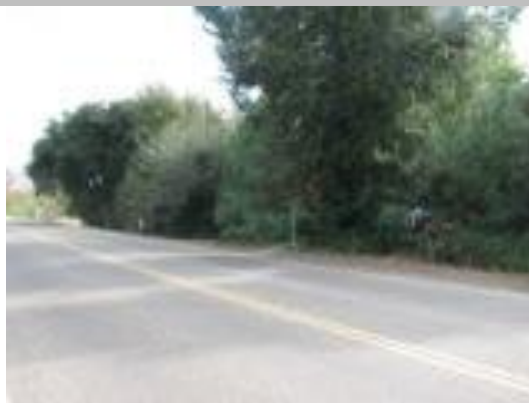
Photo 2 of 2 : SP\_2017\_MA0009\_201\_212\_20170320\_00175.jpg

The landscaping is planted on the levee slope and shoulder. Fall 2011

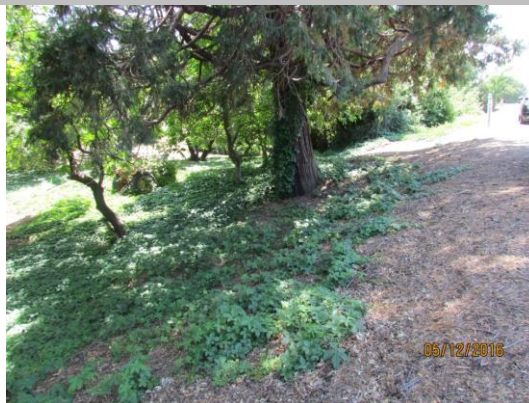
Photo 1 of 1 : SP\_2017\_MA0009\_201\_211\_20170320\_00173.jpg

LM Start	11.37	Rating **	M	Issue No.	211
LM End	11.37	Issue Type +	En	Location *	LS
Category	Earthen Levee			GPS Latitude/Longitude	
				Start	End
Item	Vegetation			38.435385 °	38.435385 °
				-121.509577 °	-121.509577 °
DWR ID	DWR_MA0009_01_s_2012_211				
Comment Code					
V6 : Landscaping					
Inspector Comment

View of the landscaping on the landward side of the levee looking downstream. Spring 2016.

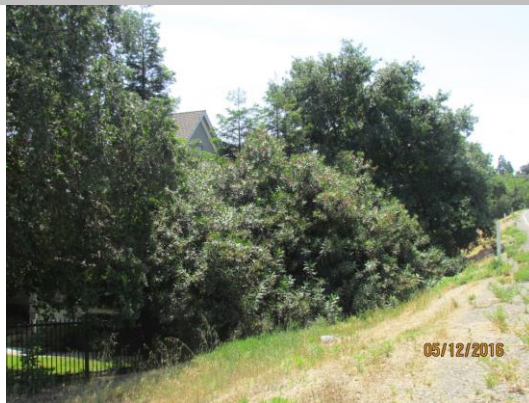
Photo 1 of 1 : SP\_2017\_MA0009\_201\_209\_20170320\_00171.jpg

LM Start	11.55	Rating **	M	Issue No.	209
LM End	11.55	Issue Type +	En	Location *	LS
Category	Earthen Levee			GPS Latitude/Longitude	
				Start	End
Item	Vegetation			38.434413 °	38.434413 °
				-121.512623 °	-121.512623 °
DWR ID	DWR_MA0009_01_s_2012_209				
Comment Code					
V6 : Landscaping					
Inspector Comment

View of the landscaping on the landward side of the levee looking downstream. Spring 2016.

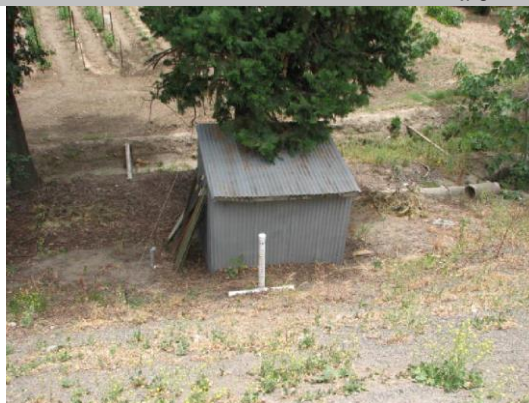
Photo 1 of 3 : UCIP\_SP\_2017\_5133\_6876.jpg

LM Start	11.66	Rating **	M	Issue No.	1816
LM End	11.66	Issue Type +	En	Location *	LS
Category	Supplemental			GPS Latitude/Longitude	
				Start	End
Item	DWR UCIP Field Study			38.434075 °	38.434075 °
				-121.514687 °	-121.514687 °
DWR ID					
Comment Code					
Inspector Comment					
FS_ID:5133 DS_ID:17461 EP_NO: N/A Repair Type: Non-Urgent Crossing Status: Found UCIP Comments: excessive brush on WS slope prevents access to gate valve on WS slope. Remove brush. FIELD_STRUCT_DESC: 6-inch pipe through levee, 16.5 feet below crown. Pump in pump house at toe of landward slope. Could not locate the gate valve on waterward slope. Originally included in O+M manual (1955). FS Date: 6/22/2012 3:08:19 PM

Pumphouse on LS toe.

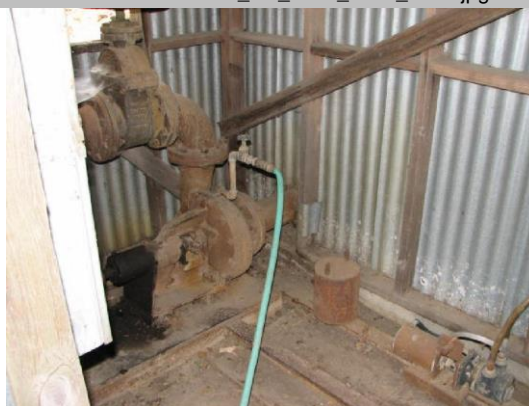
Photo 2 of 3 : UCIP\_SP\_2017\_5133\_6875.jpg

Pump in pumphouse on LS toe.

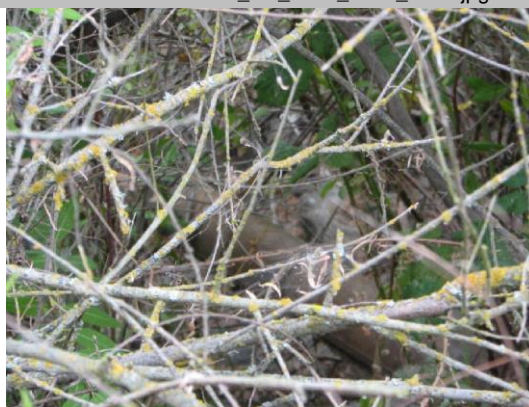
Photo 3 of 3 : UCIP\_SP\_2017\_5133\_6874.jpg

Brush covered pipe on WS slope.

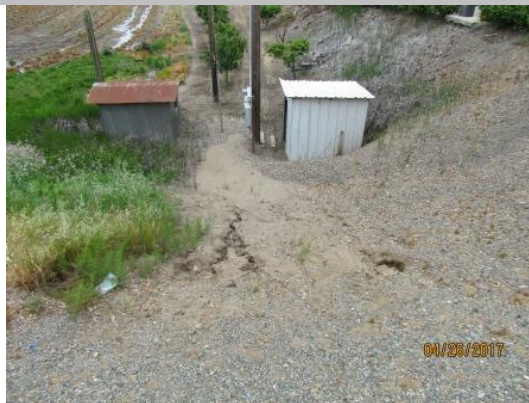
Photo 1 of 1 : SP\_2017\_MA0009\_201\_374\_20170426\_00516.jpg

LM Start	11.77	Rating **	A/W	Issue No.	374
LM End	11.77	Issue Type +	Ma	Location *	LS
Category	Earthen Levee			GPS Latitude/Longitude	
				Start	End
Item	Erosion / Bank Caving			38.433958 °	38.433958 °
				-121.516706 °	-121.516706 °
DWR ID	DWR_MA0009_01_s_2017_374				
Comment Code					
E2 : Schedule repair of erosion site prior to the next inspection.					
Inspector Comment					
Runoff erosion on landside levee slope.

View of erosion on landside levee slope. Spring 2017.

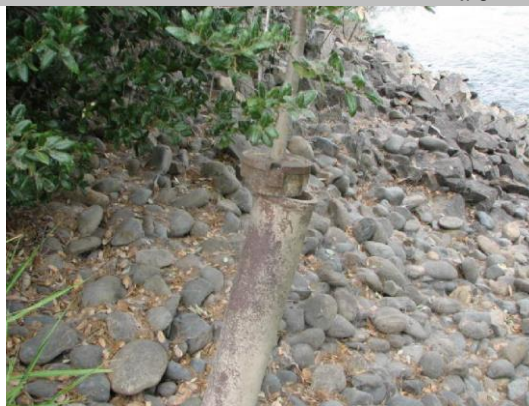
Photo 1 of 3 : UCIP\_SP\_2017\_5139\_6899.jpg

LM Start	11.78	Rating **	M	Issue No.	1817
LM End	11.78	Issue Type +	En	Location *	LS
Category	Supplemental			GPS Latitude/Longitude	
				Start	End
Item	DWR UCIP Field Study			38.433998 °	38.433998 °
				-121.516790 °	-121.516790 °
DWR ID					
Comment Code					
Inspector Comment					
FS_ID:5139 DS_ID:17673 EP_NO: N/A Repair Type: Non-Urgent Crossing Status: Found UCIP Comments: valve on WS slope does not close. FIELD_STRUCT_DESC: 2 of 2: 6-inch pipes through levee, 15.6 feet below crown. Pump and gate valve in pump house on landward side. Gate valve on WS slope. Originally included in O+M manual (1955). FS Date: 6/22/2012 3:31:00 PM

Broken or rusted valve on WS slope.

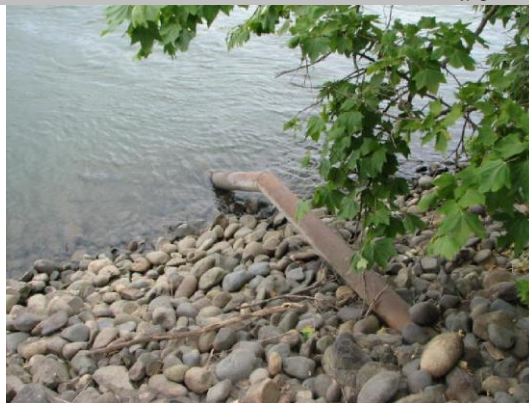
Photo 2 of 3 : UCIP\_SP\_2017\_5139\_6898.jpg

Pipe on WS slope.

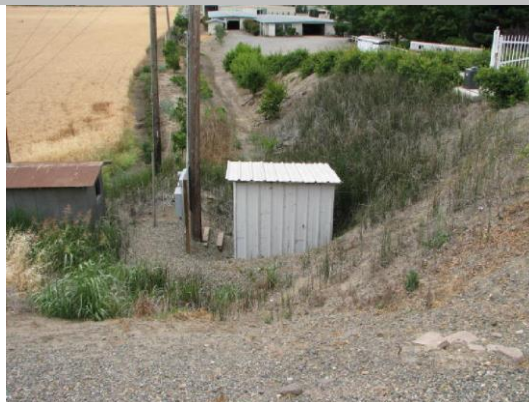
Photo 3 of 3 : UCIP\_SP\_2017\_5139\_6897.jpg

Pumphouse on LS toe with JP and meter.

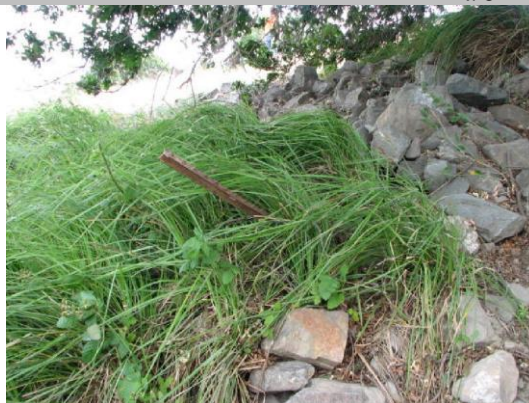
Photo 1 of 2 : UCIP\_SP\_2017\_41065\_6903.jpg

LM Start	12.29	Rating **	M	Issue No.	1818
LM End	12.29	Issue Type +	En	Location *	LS
Category	Supplemental			GPS Latitude/Longitude	
				Start	End
Item	DWR UCIP Field Study			38.433945 °	38.433945 °
				-121.526154 °	-121.526154 °
DWR ID					
Comment Code					
Inspector Comment					
FS_ID:41065 DS_ID:17581 EP_NO: N/A Repair Type: Non-Urgent Crossing Status: Indicator Found UCIP Comments: T post on WS slope and 2-inch galvanized steel pipe on LS toe may indicate ends of abandoned pipe. FIELD_STRUCT_DESC: 6-inch pipe through the levee. Pump on River side with gates on river side of levee have been removed. Originally included in O+M manual (1955). FS Date: 6/22/2012 3:50:00 PM

Tpost on WS slope.

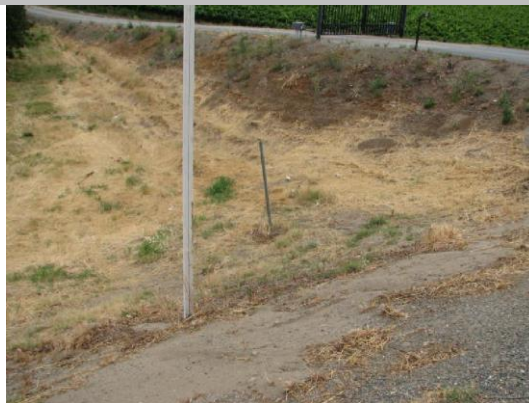
Photo 2 of 2 : UCIP\_SP\_2017\_41065\_6902.jpg

2-inch pipe on LS toe.

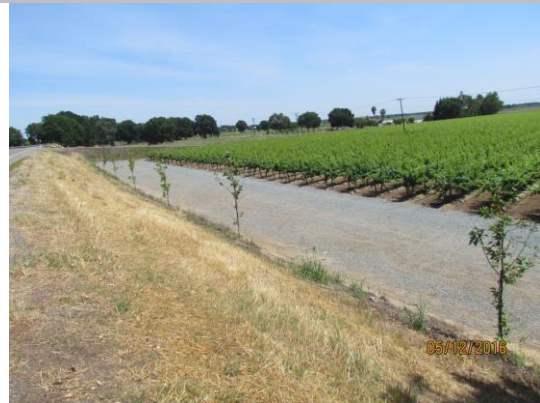
Photo 1 of 1 : SP\_2017\_MA0009\_201\_384\_20170320\_00297.jpg

LM Start	12.33	Rating **	M	Issue No.	384
LM End	12.37	Issue Type +	En	Location *	LS
Category	Earthen Levee			GPS Latitude/Longitude	
				Start	End
Item	Vegetation			38.433822 °	38.433665 °
				-121.526819 °	-121.527565 °
DWR ID	DWR_MA0009_01_s _ 2016_384				
Comment Code					
V6 : Landscaping					
Inspector Comment					
7 trees planted at levee toe.

View of the newly planted trees at the toe of the levee on the landward side looking upstream. Spring 2016.

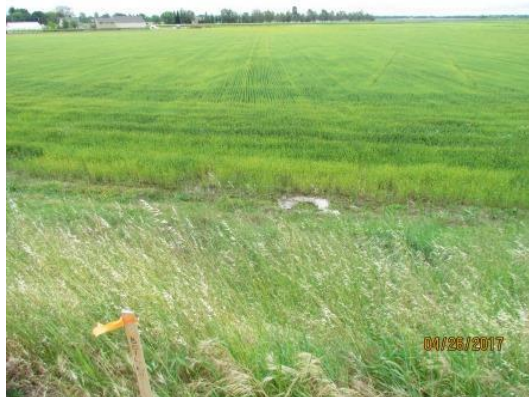
Photo 1 of 1 : SP\_2017\_MA0009\_201\_359\_20170426\_00515.jpg

LM Start	12.62	Rating **	U	Issue No.	359
LM End	12.62	Issue Type +	Ob	Location *	LS
Category	Earthen Levee			GPS Latitude/Longitude	
				Start	End
Item	Seepage / Sandboils			38.431859 °	38.431859 °
				-121.531335 °	-121.531335 °
DWR ID	DWR_MA0009_01_s _ 2017_359				
Comment Code					
Inspector Comment

View of boil at landside levee toe. It appears that the area is still saturated. Spring 2017.

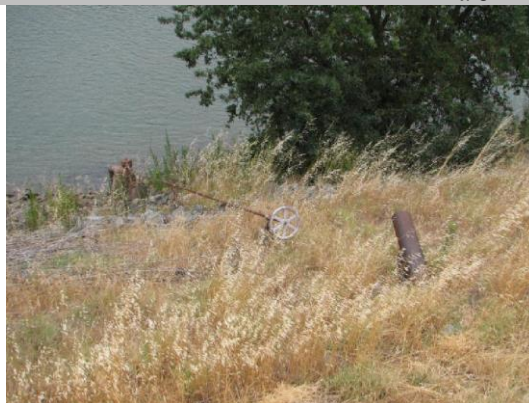
Photo 1 of 1 : UCIP\_SP\_2017\_5162\_6965.jpg

Comment Code					
Inspector Comment					
FS_ID:5162 DS_ID:17453 EP_NO: 8662 Repair Type: Non-Urgent Crossing Status: Found UCIP Comments: Further investigation is necessary to determine proper abandonment of this crossing. It is likely the 6-inch pipe on the WS is sleeved through an 8-inch steel pipe, but only the 6-inch is visible on the WS (see photo) FIELD_STRUCT_DESC: 8-inch steel pipe through levee, 9.0 feet below crown on LS. 6-inch steel pipe through WS slope 3.5 feet below the crown; grouted in place on WS. 1.5-inch steel conduit 3.5 feet below the crown next to 6-inch on WS slope. Power and service pole on landward slope. FS Date: 6/22/2012 8:51:49 AM

6-inch steel pipe grouted in place 3.5-feet below the crown.

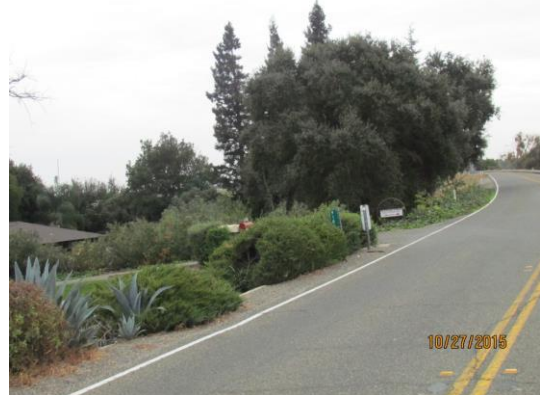
Photo 1 of 1 : SP\_2017\_MA0009\_201\_207\_20170320\_00169.jpg

LM Start	12.76	Rating **	M	Issue No.	207
LM End	12.76	Issue Type +	En	Location *	LS
Category	Earthen Levee			GPS Latitude/Longitude	
				Start	End
Item	Vegetation			38.429764 °	38.429764 °
				-121.531226 °	-121.531226 °
DWR ID	DWR_MA0009_01_s_2012_207				
Comment Code					
V6 : Landscaping					
Inspector Comment

View of the landscaping on the landward side of the levee looking downstream. Fall 2015.

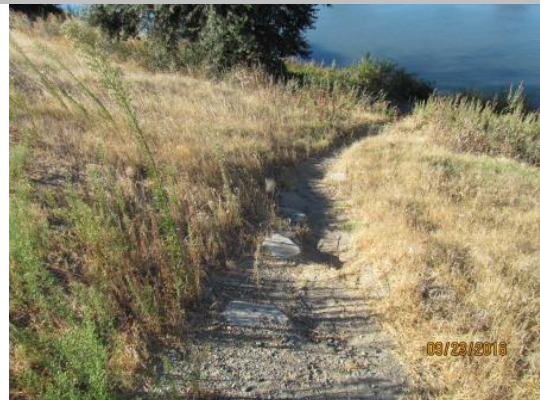
Photo 1 of 1 : SP\_2017\_MA0009\_201\_254\_20170320\_00198.jpg

LM Start	12.83	Rating **	M	Issue No.	254
LM End	12.83	Issue Type +	Ma	Location *	WS
Category	Earthen Levee			GPS Latitude/Longitude	
				Start	End
Item	Slope Stability			38.428881 °	38.428881 °
				-121.530829 °	-121.530829 °
DWR ID	DWR_MA0009_01_f_2016_254				
Comment Code					
S2 : Repair the levee slope damaged by foot traffic and prevent access where possible.					
Inspector Comment

Path made due to foot traffic. May cause slope stability issues. Stepping stones put in the ground. Fall 2016.
